IRON ORE BIN REMEDIAL WORKS

GERALDTON, WA

Karara Mining Iron Ore Bin Remedial Works

Karara Mining

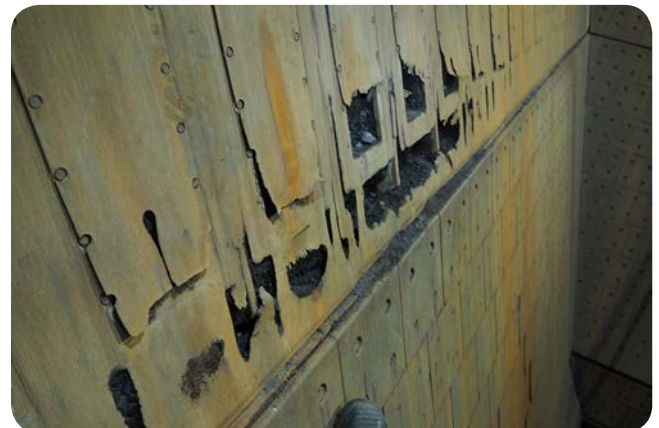
Also included was the installation of specially fabricated 2,987kg plates. Given the particularly high density composition of the magnetite which is processed at the mine, the parent metal was found to be severely damaged.

- ▶ Overview of the iron ore mine site.
- ▶ Typical signs of wear to the screening bins liner plates.
- ▶ Welders removing damaged liner plates.

Duratec was engaged to perform remedial works inside Karara Mining's iron ore screening bins during a six day outage. The scope involved the removal of worn liner plates and replacement with new hardened Bisalloy Bisplate 500 liners.
